An innovative solution for township roads in sandy areas

By P Paige-Green*
and Eben Gerrits**

This paper describes the design and construction process of an innovative road pavement structure for a township in an area which has a total lack of traditional road construction materials. The project is in the Dukuduku area of KwaZulu-Natal north of Mtubatuba.

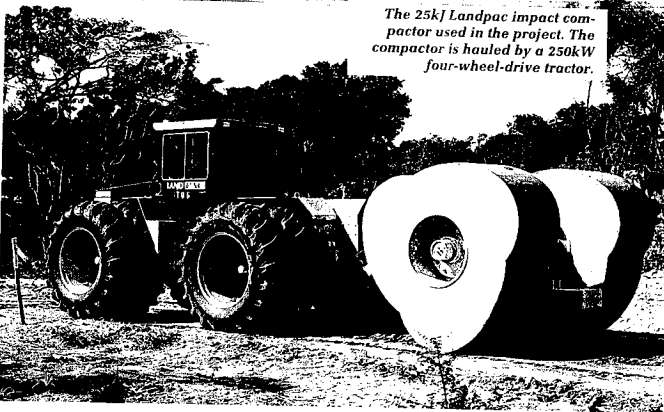
The 25kJ Landpac impact compactor used in the project. The compactor is hauled by a 250kW four-wheel-drive tractor.

Compaction was carried out with a three-sided Landpac 25kj impact compactor. Twenty five passes of the compactor were applied and the *in situ* strengths before and after rolling were monitored with a 2m DCP, together with the settlement which is determined by comparing the average level of the rolled surface with a predetermined datum.
