# CAPSA'04

## TYRE-PAVEMENT INTERFACE CONTACT STRESSES ON FLEXIBLE PAVEMENTS – **QUO VADIS?**

Morris De Beer, C. Fisher and  
L. Kannemeyer

CSIR TRANSPORTEK

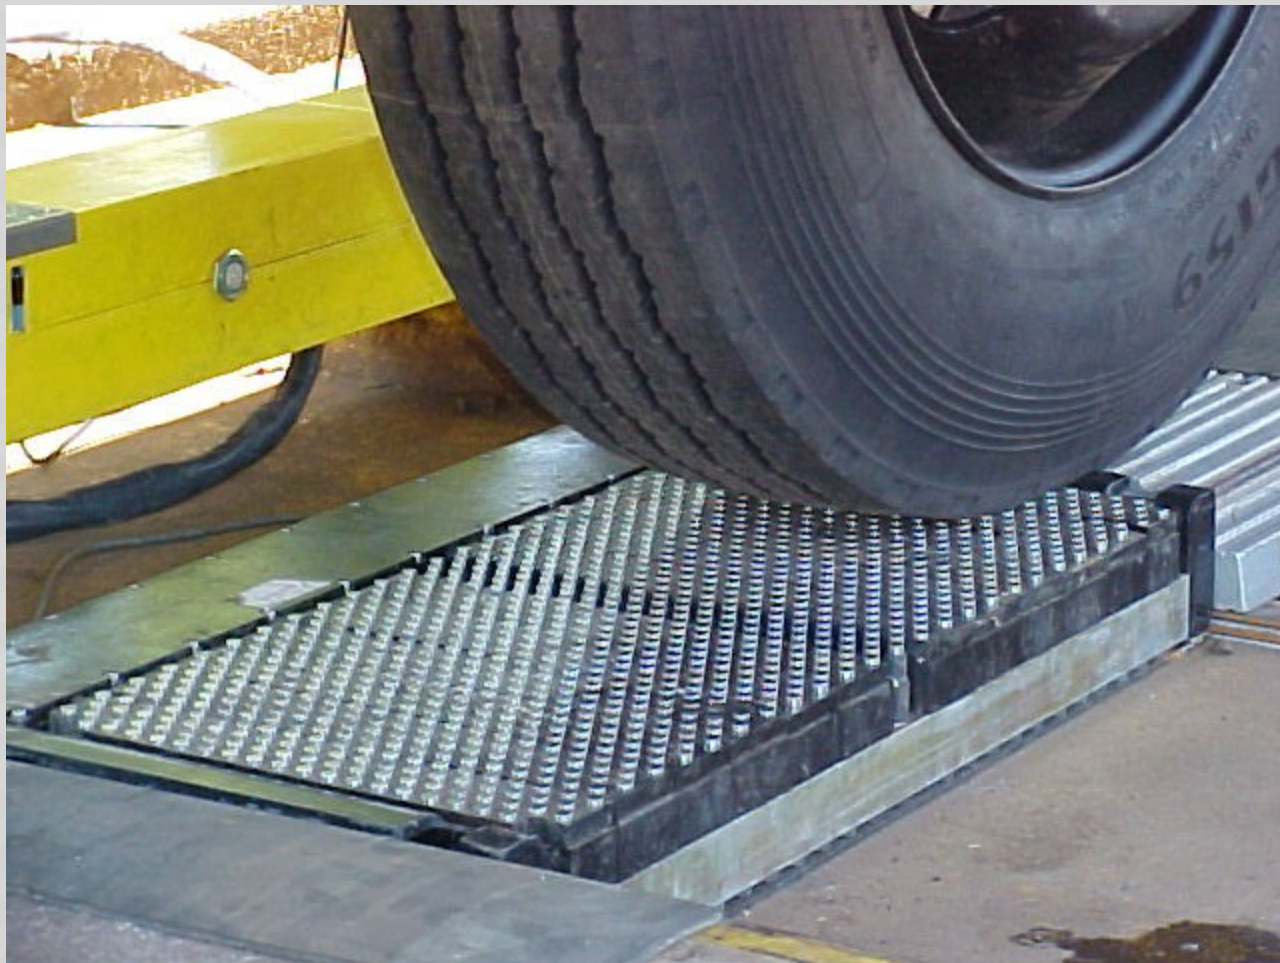
# Stress – In – Motion (SIM) Technology – Single Pad – APT environment

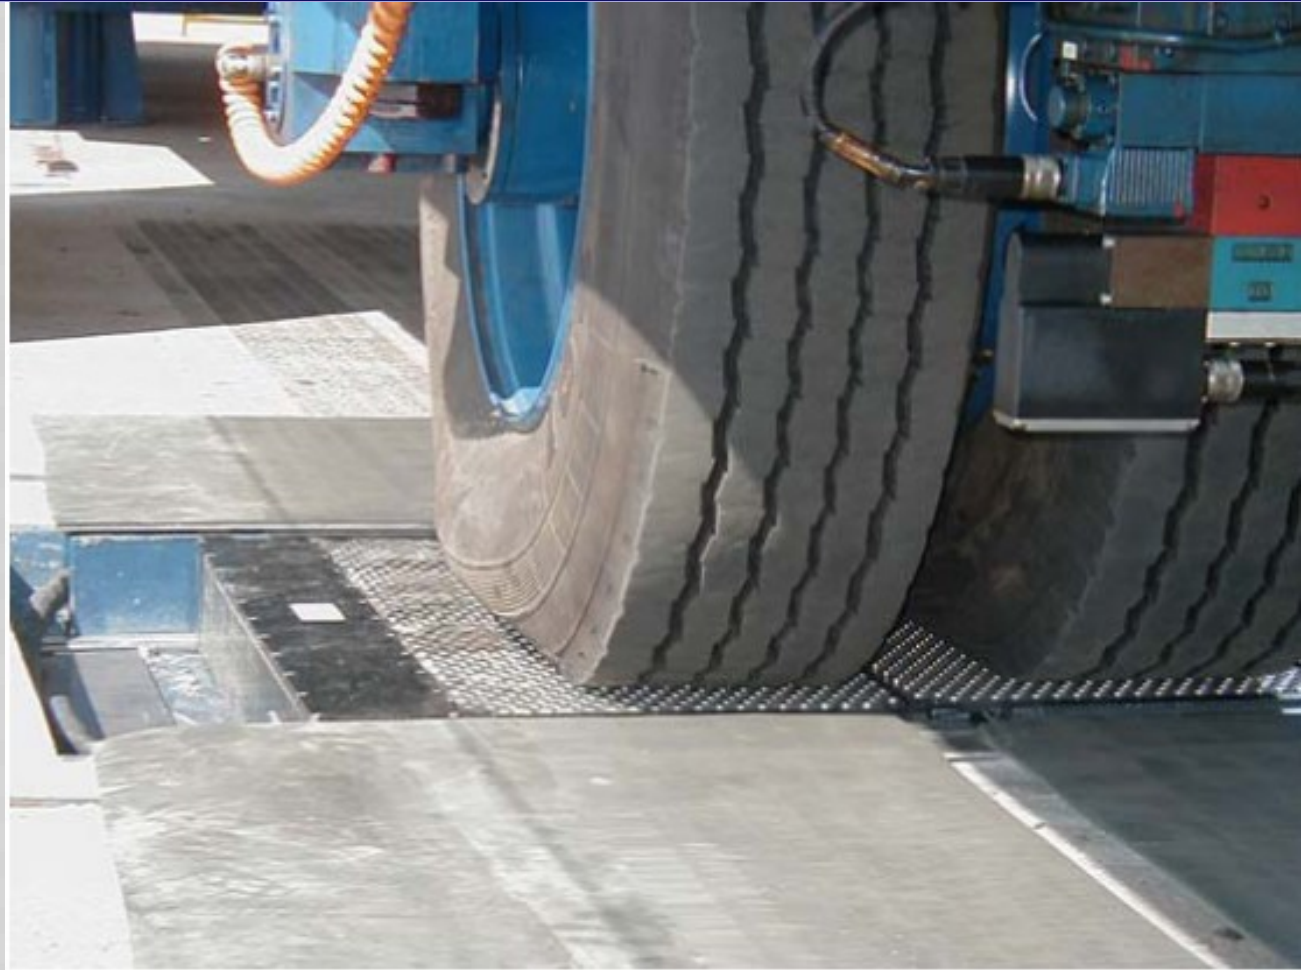
# Stress – In – Motion (SIM) Technology – Dual Pad – APT environment

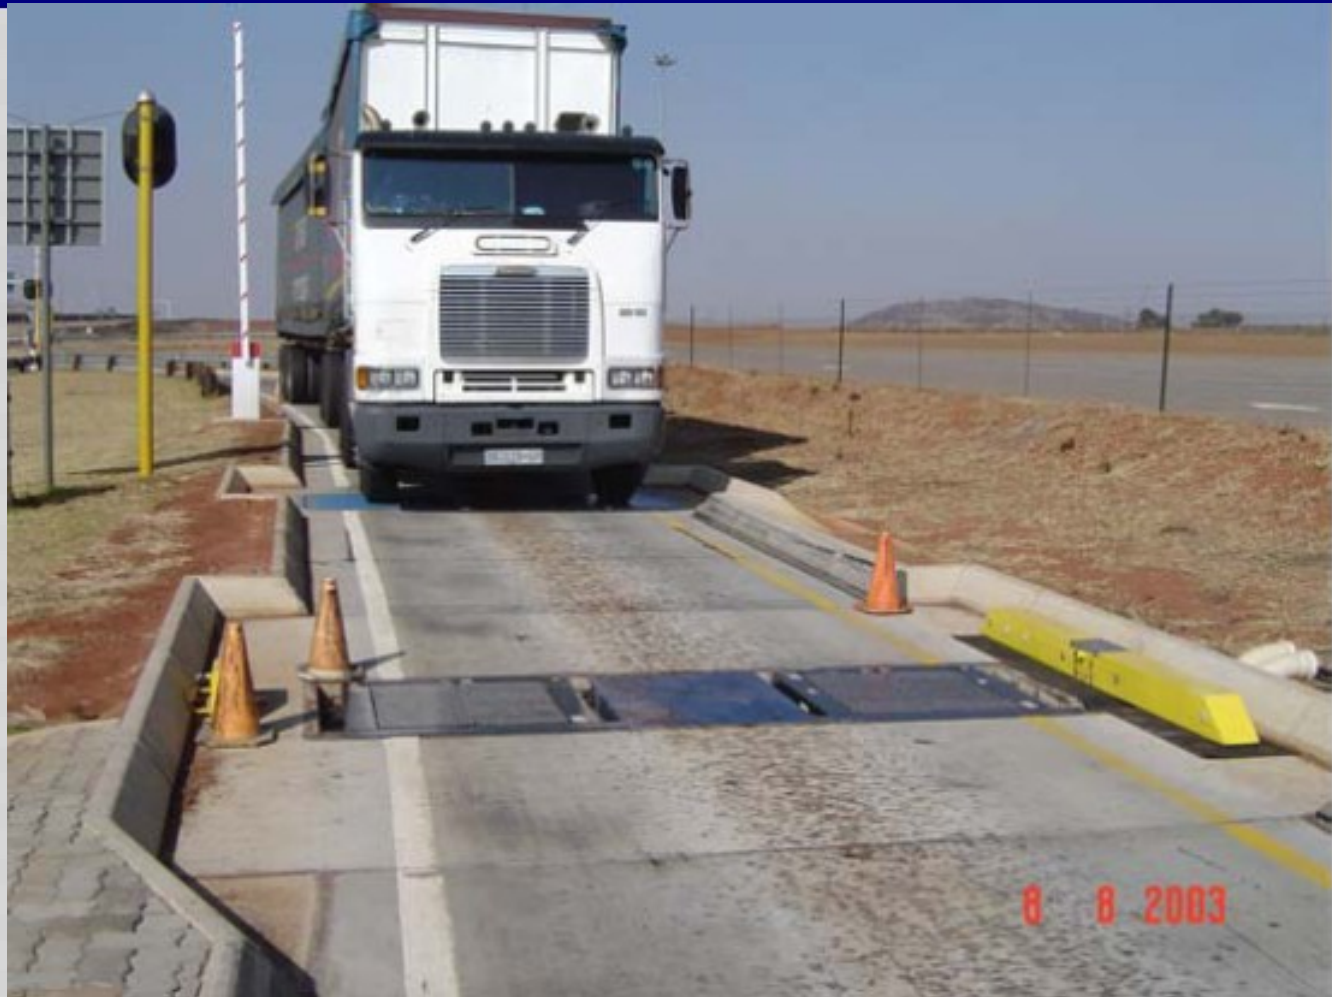
# Stress – In – Motion (SIM) Technology – 4 PAD – N3 - TCC
